Homeowner's Guide

2025 - 2026

My Safe Florida Home Program

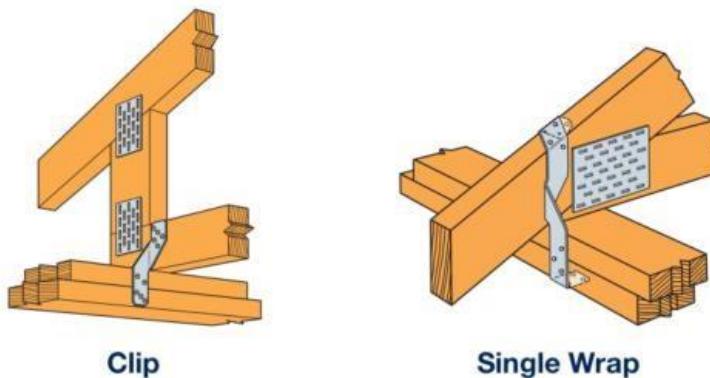
Roof to wall attachments are connections that attach the attic trusses or rafters to the walls of the home reducing the possibility that all or a portion of the roof will lift off the home during a hurricane. **While roof to wall attachments can often be upgraded without replacing a roof, the cost of replacing the roof may be eligible for Grant funding if necessary to complete the Recommended Improvement.**

- Secured to truss/rafter with a minimum of three (3) nails; **AND**
- Attached to the wall top plate of the wall framing, or embedded in the bond beam, with less than a $\frac{1}{2}$ " gap from the blocking or truss/rafter and blocked no more than 1.5" of the truss/rafter, and free of visible severe corrosion.

Some examples of these attachments are clip connections, single-wraps, and double-wraps.

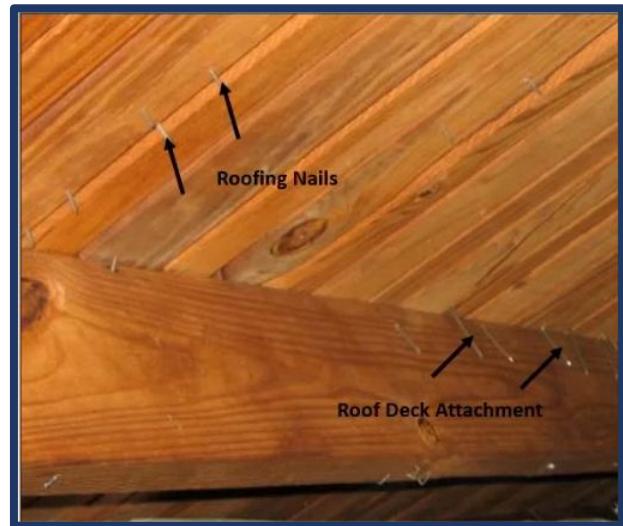
The Roof Deck Attachment can be improved by installing additional nails or longer nails to bond the roof sheathing (most commonly: plywood sheets) to the trusses or attic rafters.

When installing a roof to the current code, a licensed Roofing Contractor will ensure the roof sheathing (e.g., plywood) is nailed down to the trusses or rafters with the proper nails and spacing. This helps hold the roof deck to the trusses/rafters in the event of a windstorm and should ensure it qualifies for the proper windstorm mitigation credit.

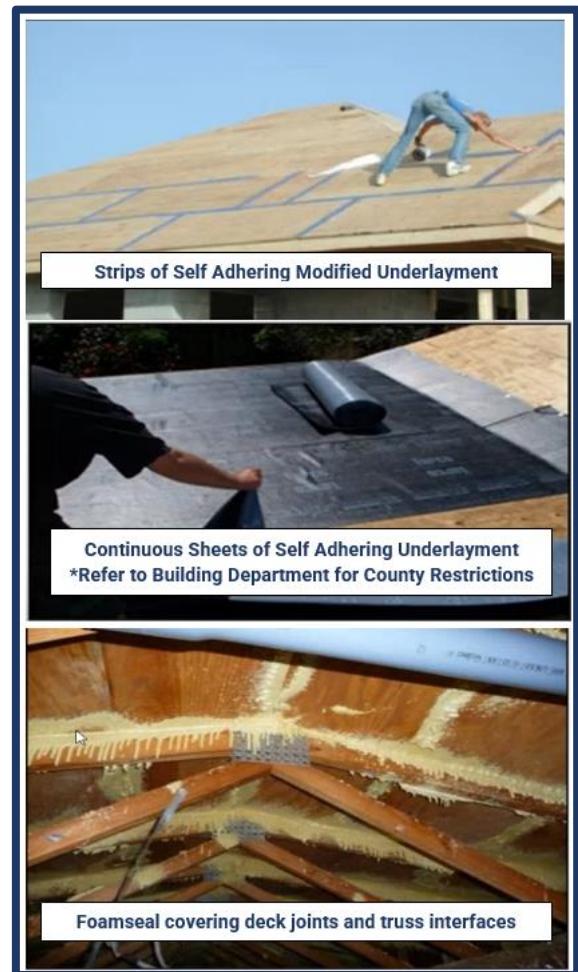
A Secondary Water Resistance (SWR) is an underlayment material that is self-adhered (peel-and-stick) and positioned directly to the roof deck to prevent water intrusion. This material can be full roof coverage, seam-tape (a 6" wide roofing tape covering all the seams of the roof deck material), or cell spray foam adhesive used in the attic space which seals every seam of the roof deck and on either side of the trusses or rafters.

1. At the time of reroofing, use a full-coverage self-adhered underlayment, commonly referred to as peel-and-stick, directly to the roof deck material.
2. At time of reroofing, use a self-adhere product, commonly referred to as seam tape, on all joints and seams of the roof decking material. This still requires nailed down underlayment such as felt paper; or
3. If not replacing the roof, install a foam adhesive on all the seams and joints from the attic side of roof.
